Road safety in rural roads of two lanes

Seguridad vial en carreteras rurales de dos carriles

R. García ^{1*}, L. Abreu *

* Universidad Central de Las Villas, Santa Clara, Villa Clara. CUBA

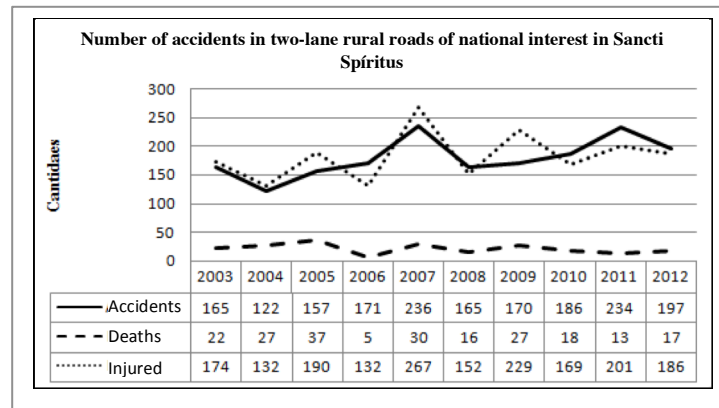
According to reports from the province's Commission of Road Administration and Traffic, the average annual number of accidents, deaths and injured on the nation's rural two-lane highways in the Sancti Spiritus province for the period from 2003 to 2012 was 190 accidents, 18 deaths and 187 injured. Figure 1 presents the results per year.

Figure 1. Number of rural accidents in Sancti Spiritus

The year with the most problems in the number of accidents 2007, which coincides with the beginning of the reinstatement of traffic flow in that area. It is the year with the most accidents involving deaths and injuries, as well as accidents with injuries, according to the classification of

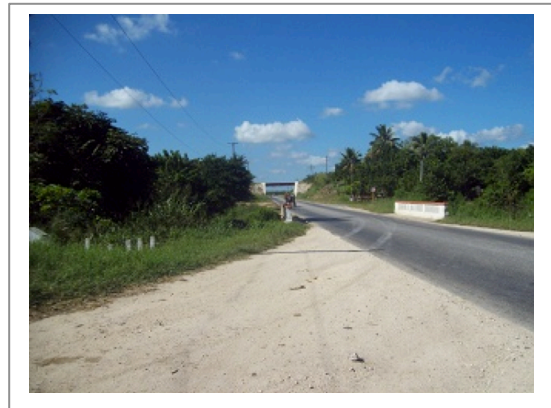
Determination of risk factors. The risk factors detected in Segment 4 are described below, and an example is shown in Figures 2 and 3:

- Lack of horizontal signage
- Unlit segment
- Pavement surface is deteriorated and worn away.
- Difficulties with drainage
- High operating speed for the type of area
- Train overpass above the highway
- High percentage of slow vehicles in the mix of vehicles, which generates dangerous passing of vehicles
- Disorderly movement and circulation of the more vulnerable vehicles

Figure 2. View of Segment 4

- Illumination throughout the entire segment, giving priority to the area of the train overpass.
- Repaving of the entire segment
- Reopening and repair of ditches
- Treatments for the current vehicular intersections
- Increase police controls

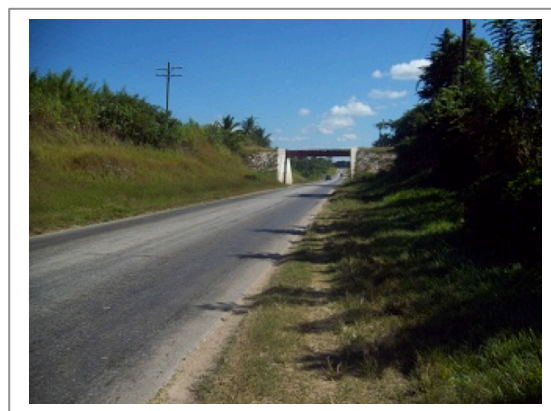
Figure 3. Views of Segment 4
